Case Study EC Fan Upgrade Leisure Centre, Dorset

Case Study - Leisure Centre, Dorset - EC Fan Upgrade

Dorset Leisure Centre - EC Fan Upgrade

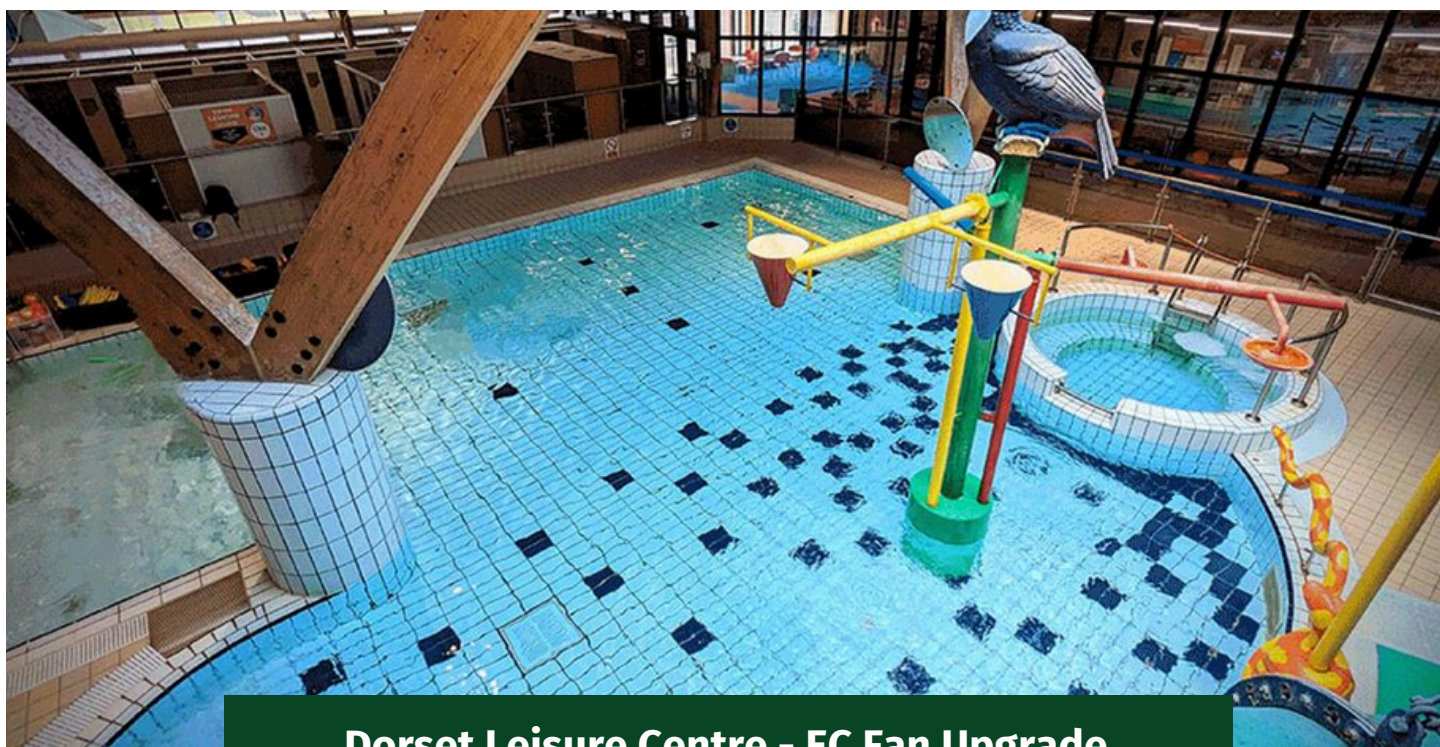
When BVS first inspected the swimming-pool air-handling unit (AHU), it was clear the system was no longer protecting either the building fabric or the comfort of pool users. Filters were missing on both supply and extract sides, allowing debris to clog the heating coil and plate heat exchanger. Fresh-air and exhaust dampers were closed, the return-air plenum was corroded and drawing plant-room air, and the condensate pan was leaking badly. Supply and extract fans had shredded belts and produced excessive noise, and almost no airflow reached the pool hall.

As a result, humidity and temperature control were virtually non-existent—any warmth came only from the pool's thermal mass, risking serious long-term damage to the building. Since that initial visit, a temporary bearing repair kept the extract fan running, but a permanent solution was essential. After a detailed site survey and airflow measurements, BVS designed a targeted upgrade to restore proper ventilation, improve energy efficiency, and safeguard the structure.
