# Case Study AHU Refurbishment Gresham Street Office

# Case Study - Gresham Street Office

The existing air handling unit (AHU) required refurbishment to enhance operational efficiency and adapt to new air volume requirements.

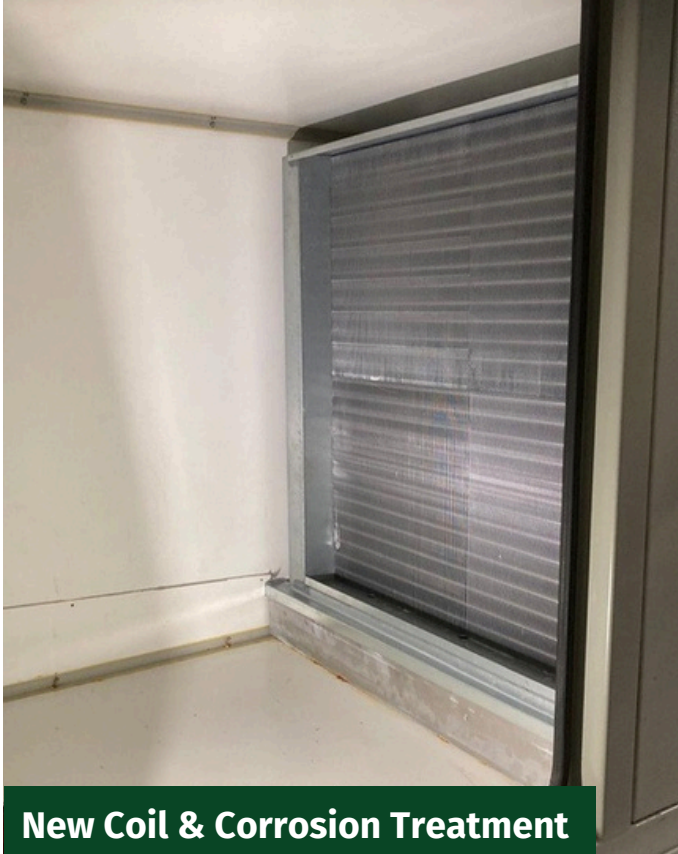
**New Coil & Corrosion Treatment**

## **Cooling Coil:**

The existing cooling coil, integral to temperature regulation, was replaced with a new coil designed to handle the revised air volume requirements more effectively.

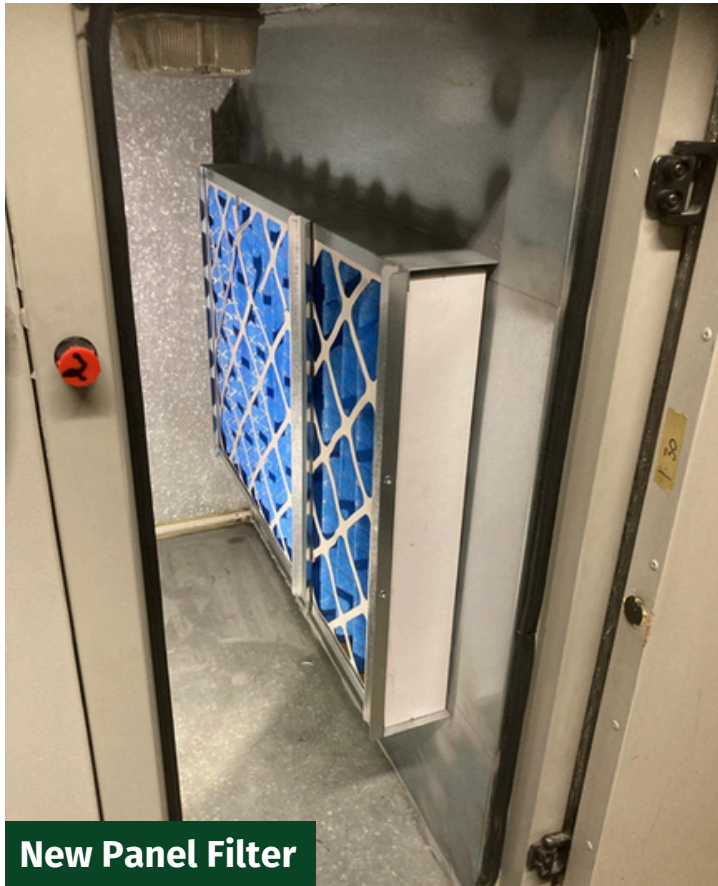
New Panel Filter

Both panel and bag-type filters were removed. These filters were found to be inefficient for the updated system requirements and were replaced with new filters designed for improved air quality and system efficiency.

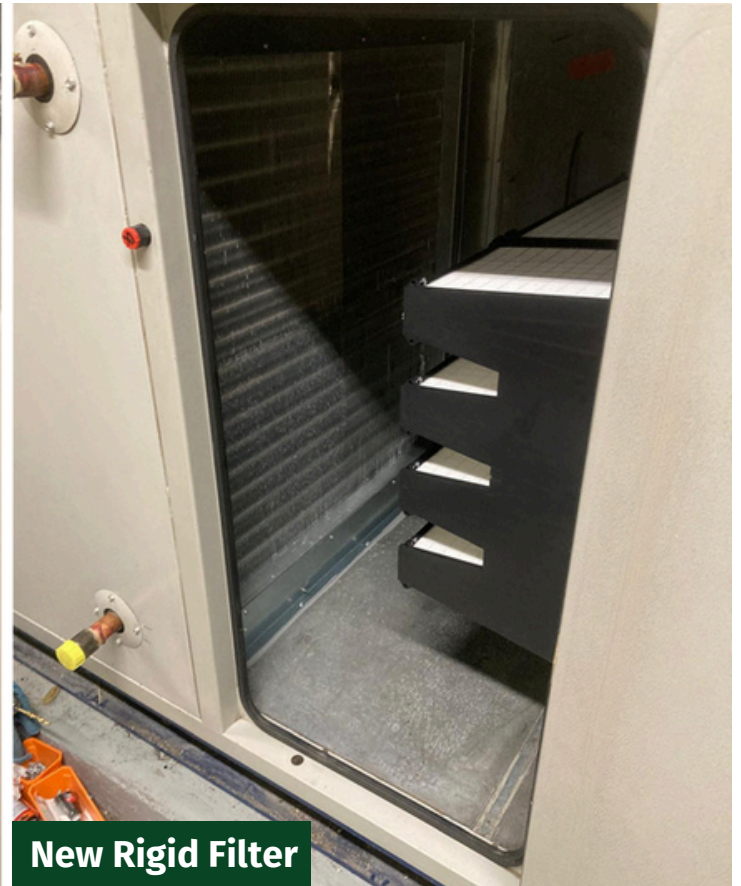
New Rigid Filter
