# FOREST OF ARDEN SWIMMING POOL

## VENTILATION TROUBLESHOOTING & SOLUTIONS

## PROJECT OVERVIEW

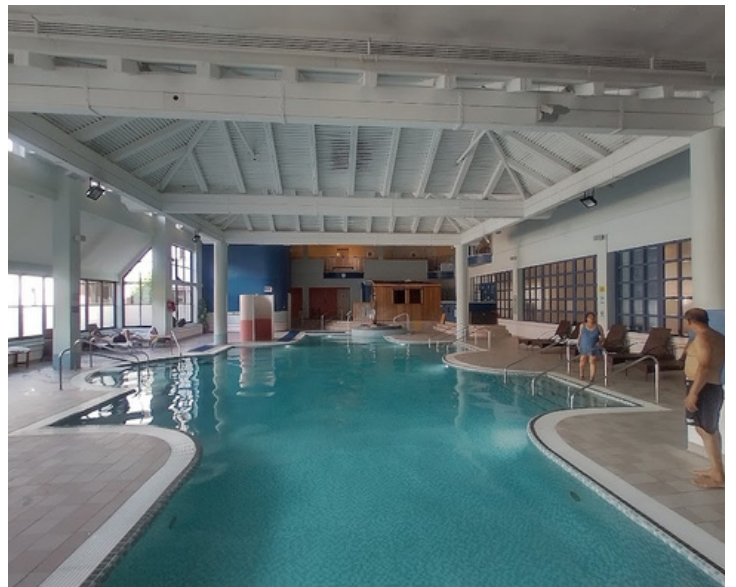
The project involved the validation and surveying of the Air-Handling Unit (AHU) serving the swimming pool hall. The AHU, installed three years ago, was responsible for supplying and extracting air to maintain a temperature of approximately 31°C. However, the client reported that the maximum temperature achieved since the installation of the AHU was only around 24°C.

The investigation covered various aspects of the installation, including air volumes, temperatures, ductwork layout, and air distribution system. The case study highlighted the issues affecting the swimming pool hall's air temperature and proposed a range of measures to address them.

- Relocate the fan on its bulkhead away from the heating coil to improve airflow.
- Install a baffle after the heating coil to distribute air more evenly.
- Swap the supply fan access door with the service door to improve maintenance access.
- Fit a mesh guard on the silencer inlet to prevent vermin ingress.

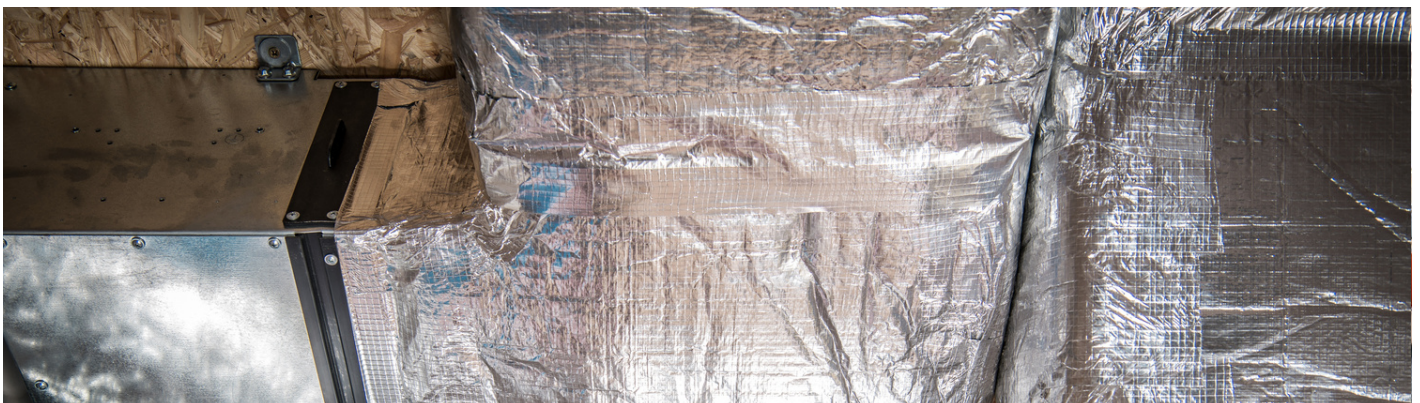
- The existing galvanised ductwork, around 30 years old, showed significant leaks, resulting in pressure drops and air loss.
- High-level slot diffusers used for air distribution were inadequate, with velocities measuring around 1m/s, insufficient for effectively moving warm air downwards.

- Modify the linear slot diffusers to improve velocity and directional airflow.
