BUILDING VENTILATION SOLUTIONS

Newton Mearns, Glasgow AHU Refurbishment & Pipework Replacement

Introduction - Newton Mearns Shopping Centre

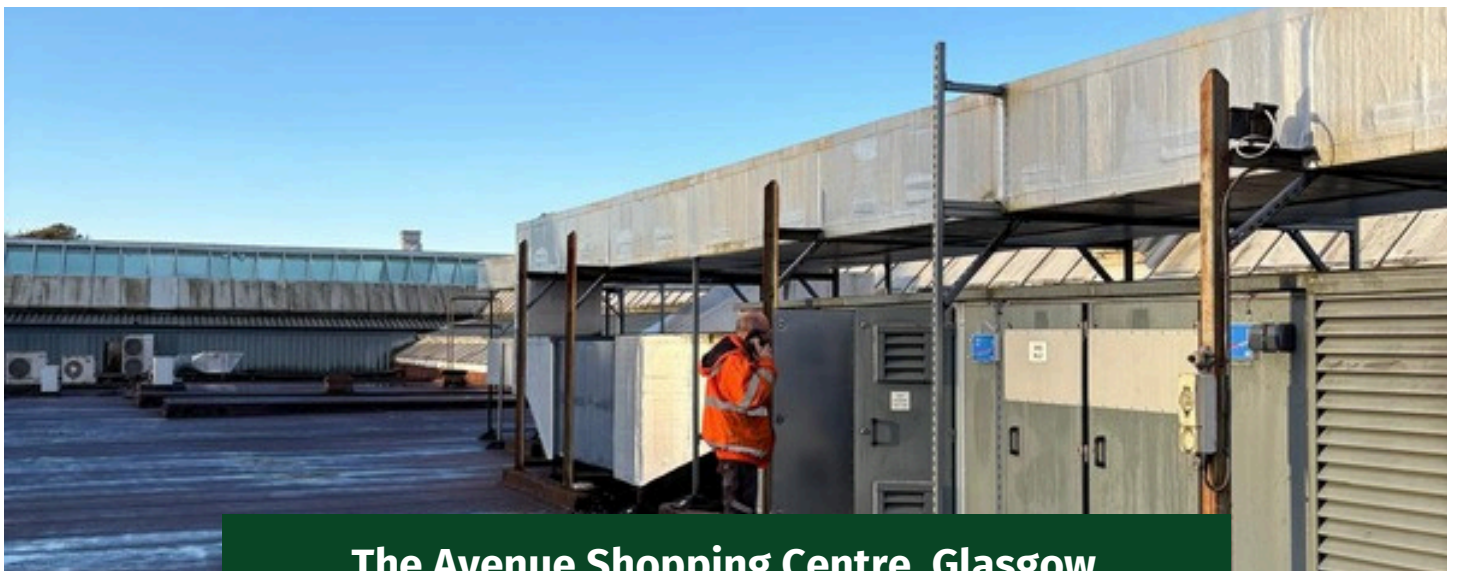
Each AHU underwent a complete refurbishment, including the removal of existing components and installation of high-efficiency backward-curved supply fans and EC extract fan walls to reduce energy usage and improve airflow control. The original direct-fired gas burners were replaced with modern, fully modulating models compatible with current gas safety standards and integrated into the existing Trend control system. All internal and external surfaces showing corrosion were cleaned and treated, new panel and bag filters were installed, and lighting and access components were renewed to restore safe, efficient, and reliable operation across all three units.

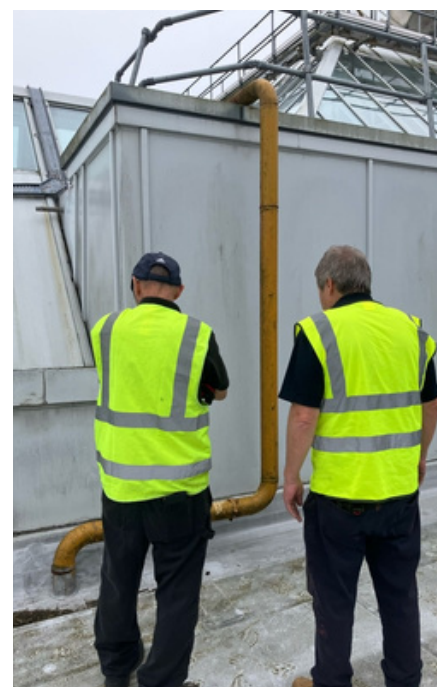
New gas burners and EC fans were integrated with the existing Trend control infrastructure, with commissioning works verifying full modulation, speed control, and operational synchronisation to achieve optimal efficiency and balanced airflow.

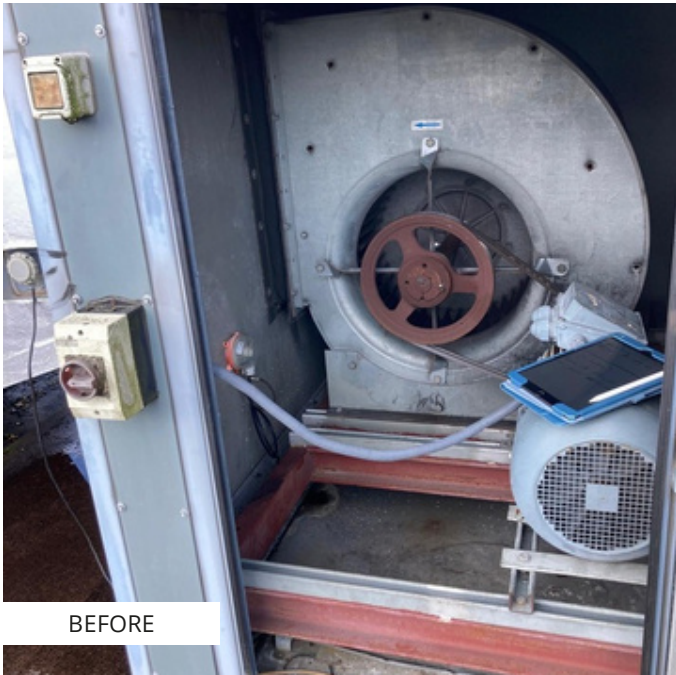
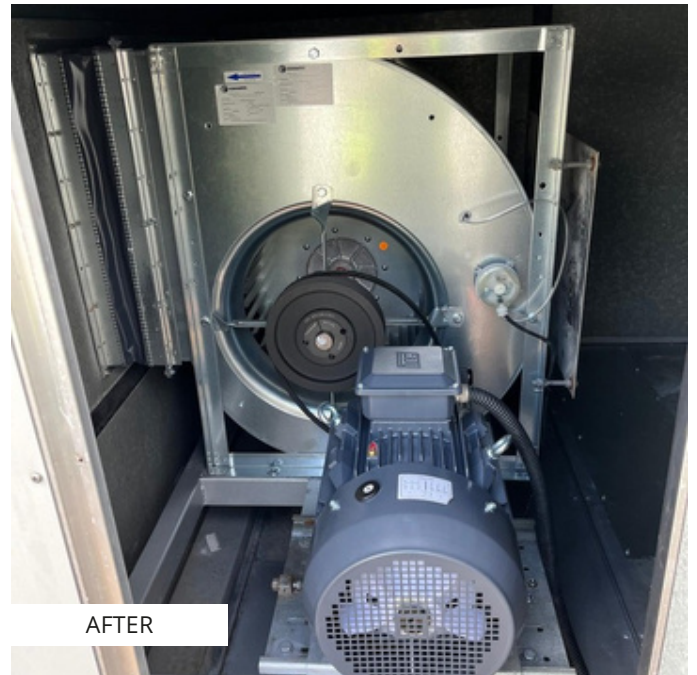
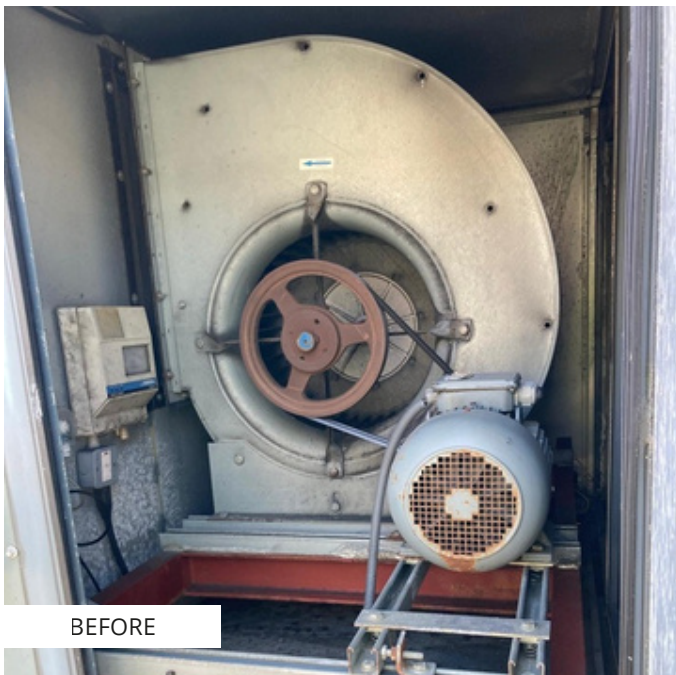
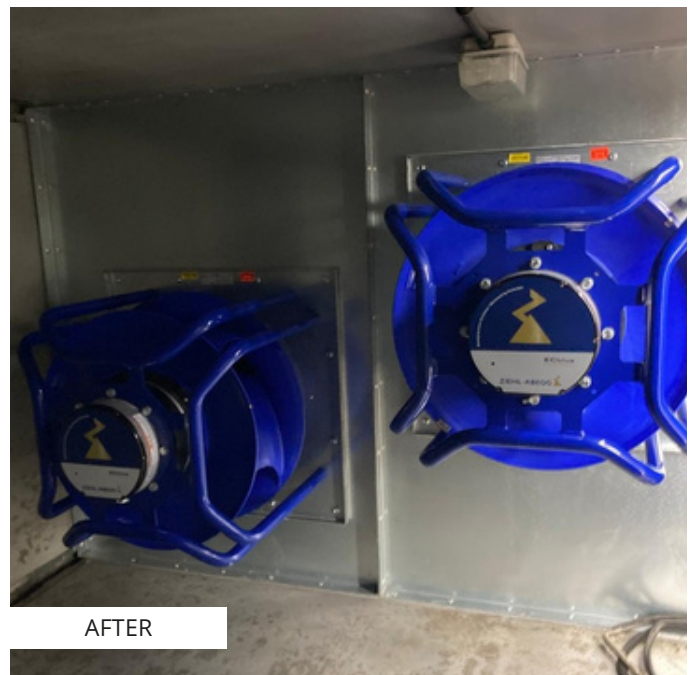
The existing belt-driven fans were replaced with modern, equivalent belt-driven units to enhance reliability and maintain system performance.

The existing belt-driven fan was replaced with a high-efficiency EC fan to improve performance and reduce energy consumption.

Belt-Driven Fan Replacement

EC Fan Upgrade

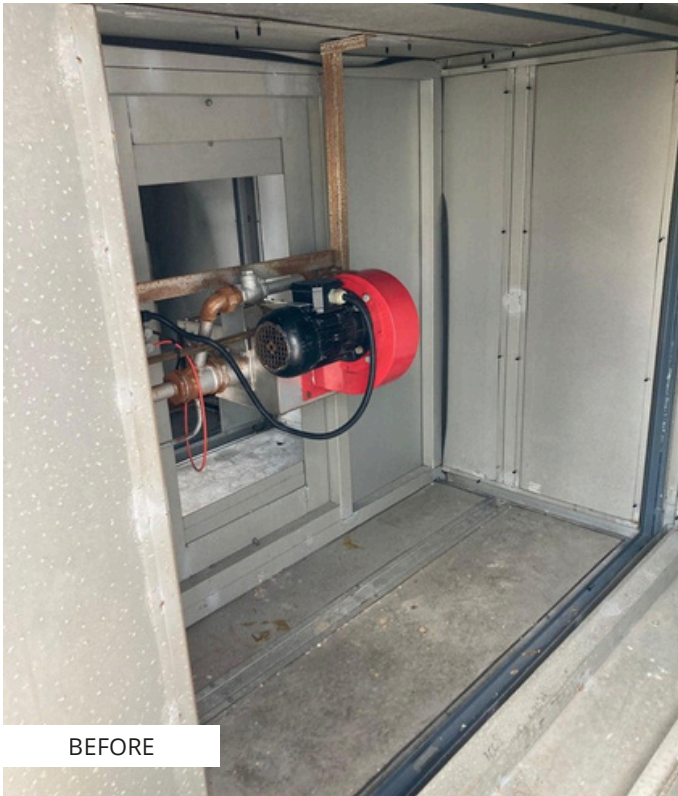
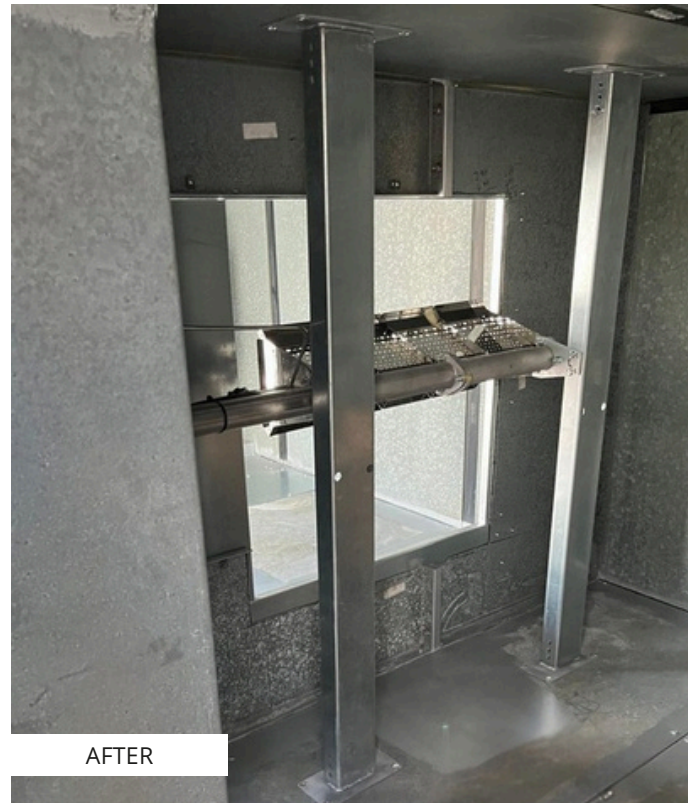
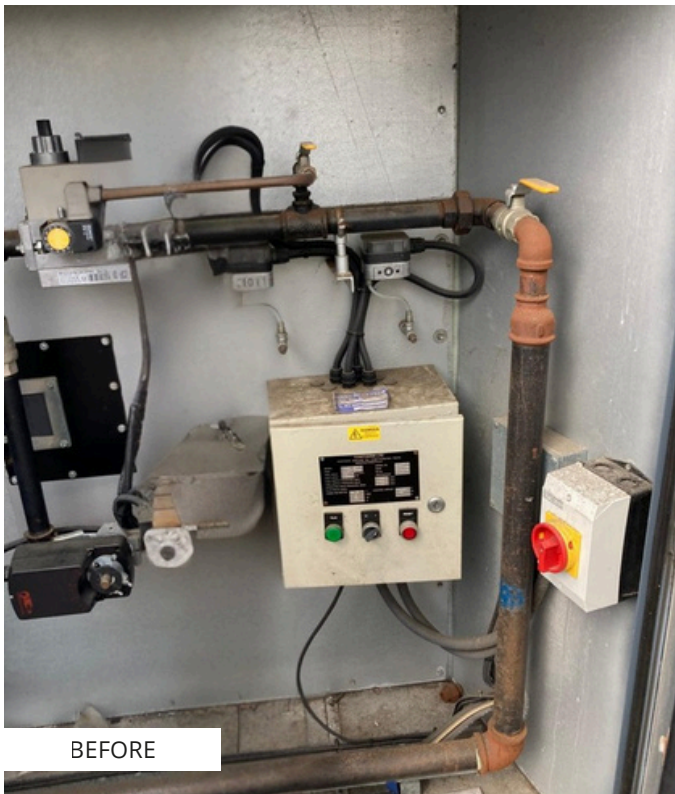
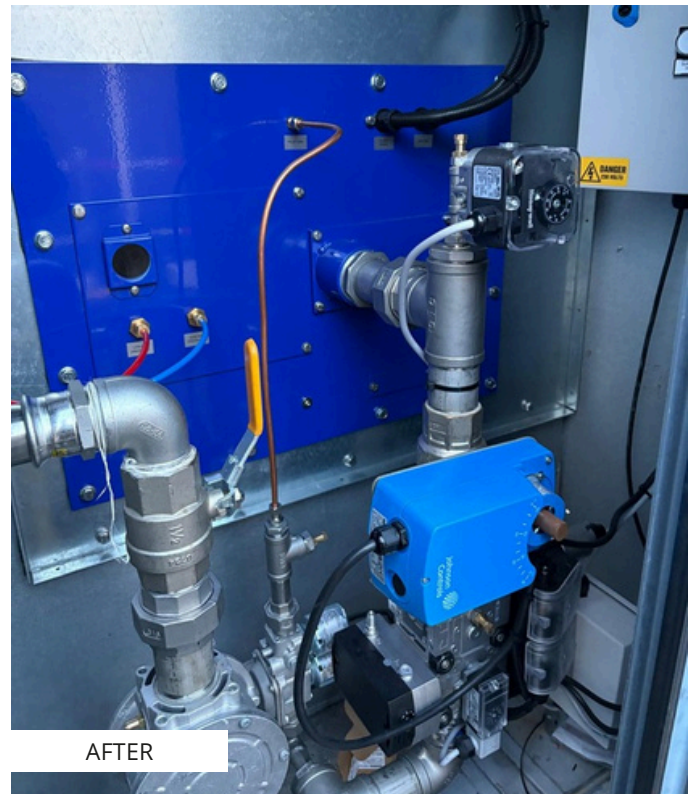
The existing gas burner was removed and replaced with an upgraded model compliant with current gas safety standards and fully integrated into the existing Trend control system.

Gas Burner Upgrade

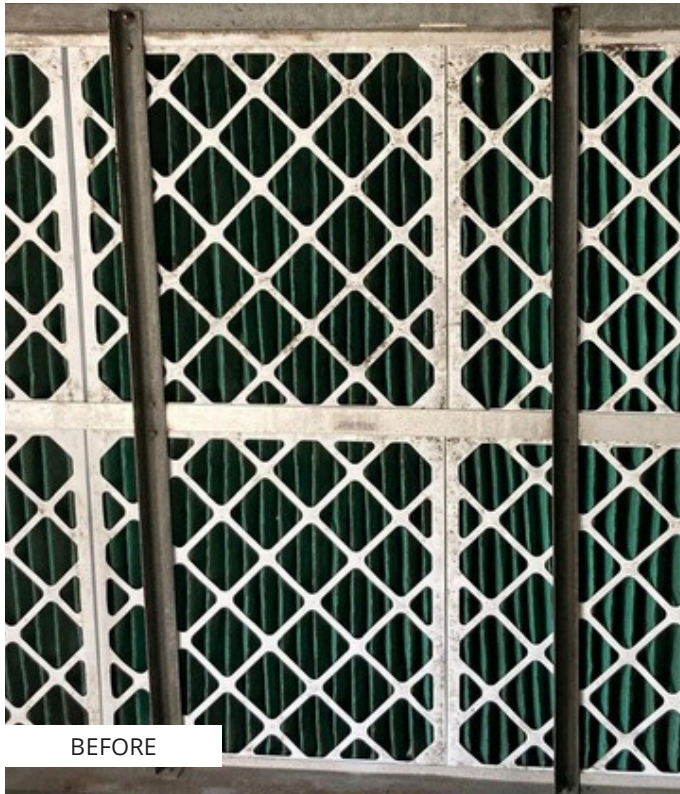
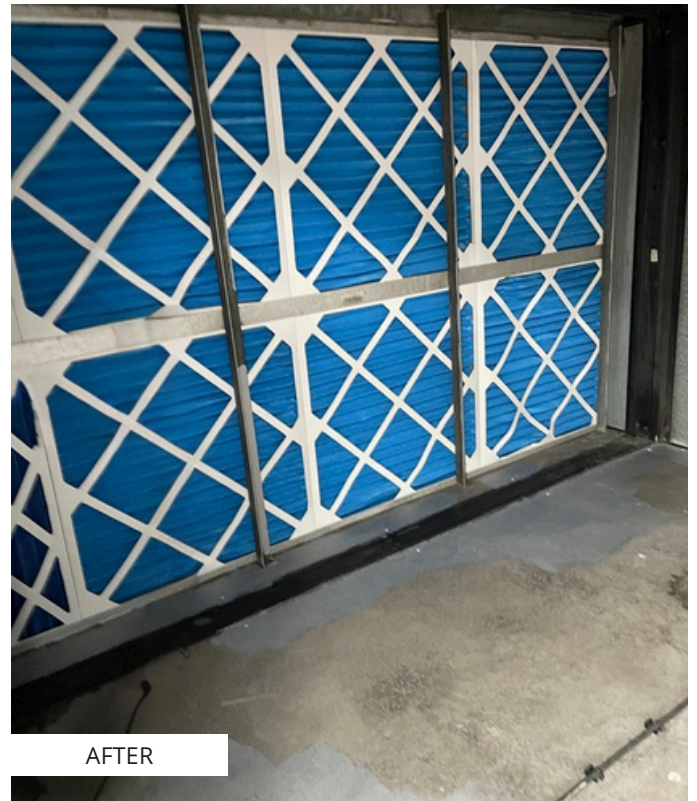
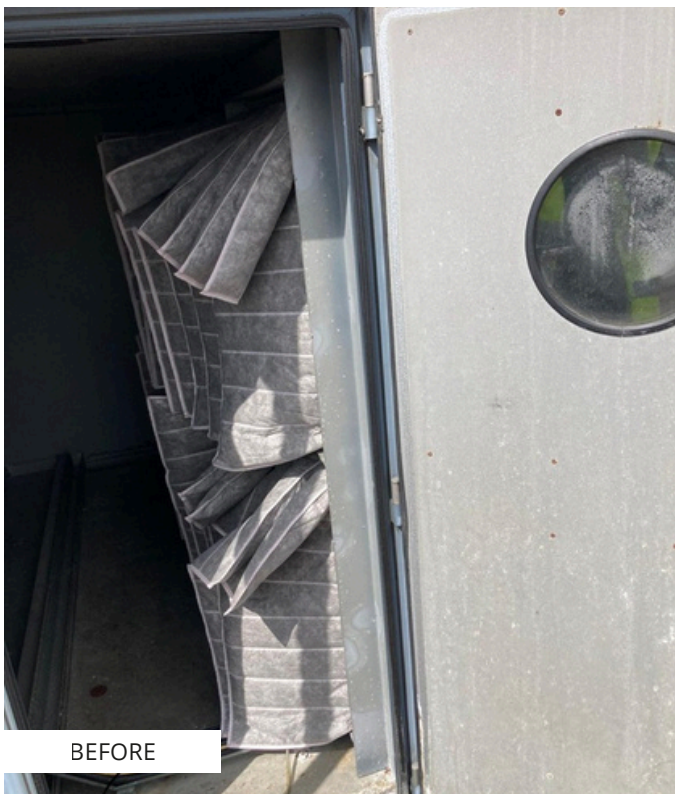
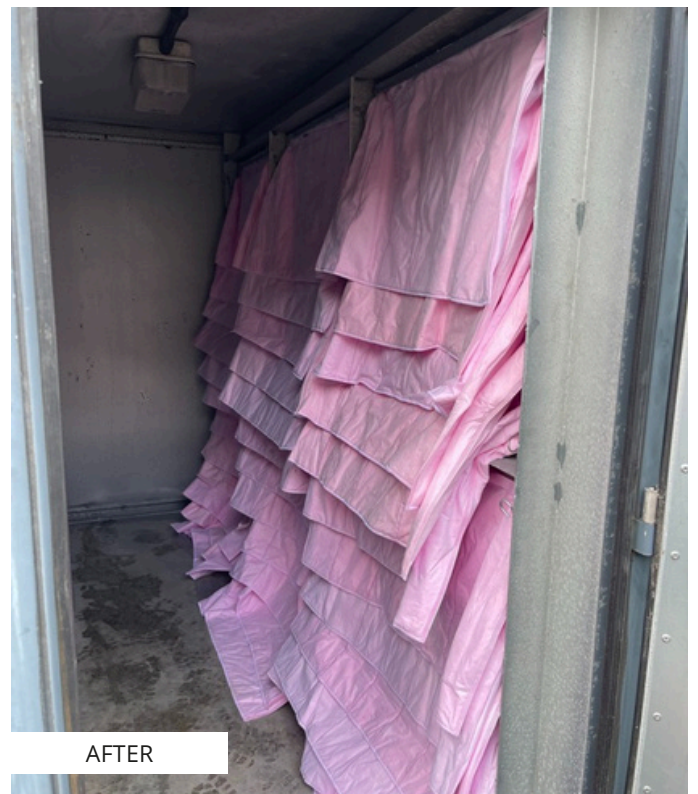
The panel and bag filters were upgraded to AF101 Type AP and AB85 Type respectively, improving air quality, filtration efficiency, and overall system performance.

Panel & Bag Filter Upgrades

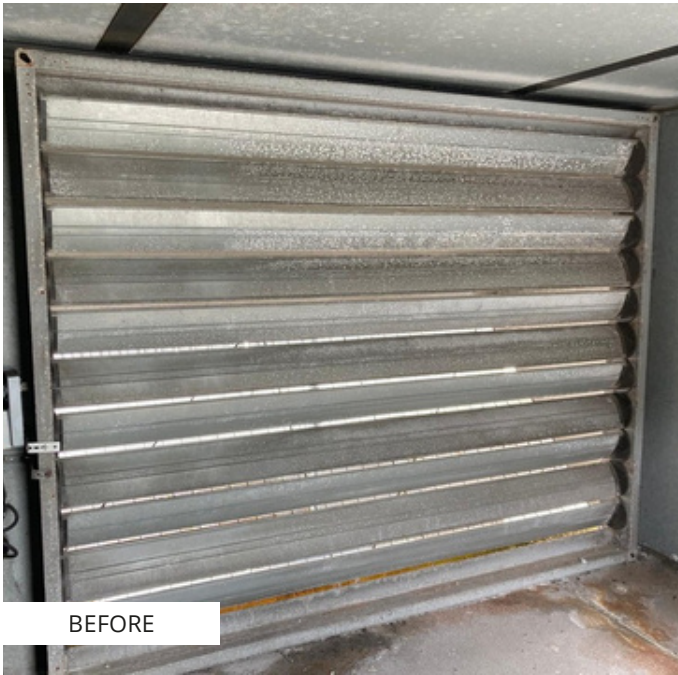
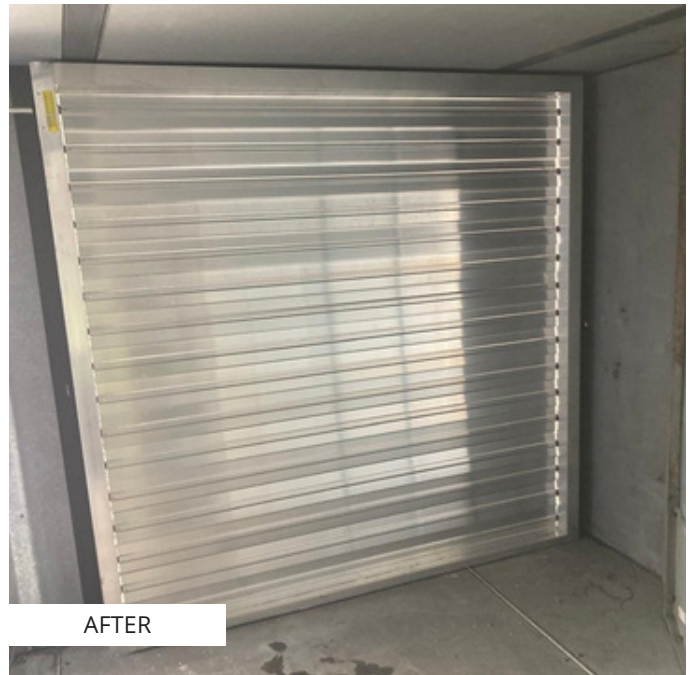
The existing dampers were replaced as the original units had seized and were no longer operational, ensuring reliable airflow control and improved system performance.

Damper Replacement

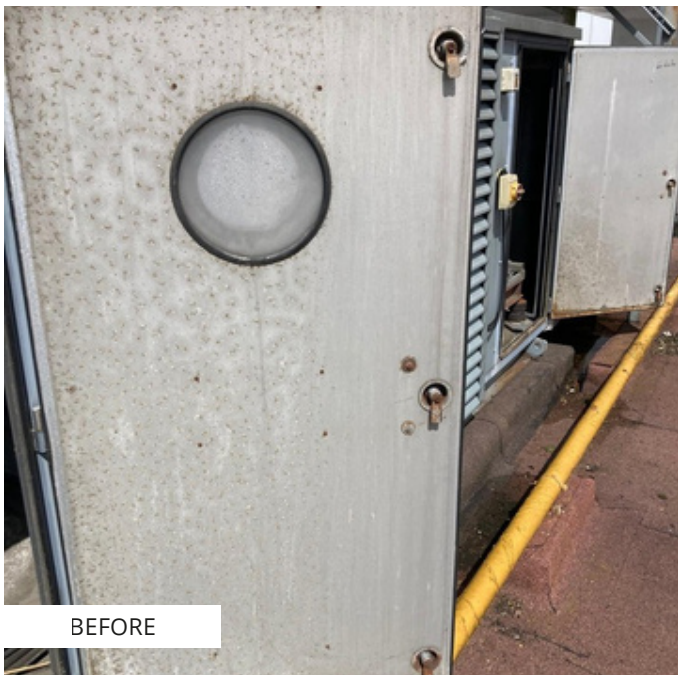
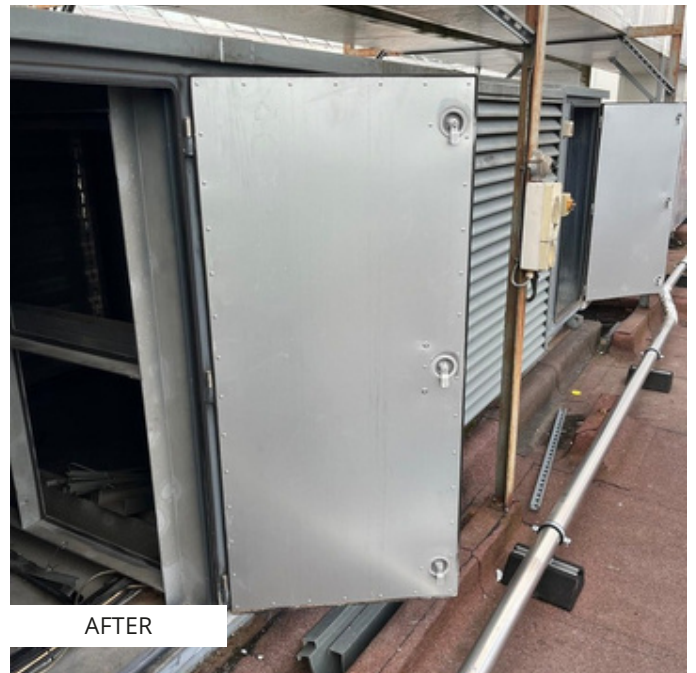
The AHU doors and catches were replaced due to corrosion on the existing units and evidence of water ingress and restoring proper sealing.

AHU Door Replacements

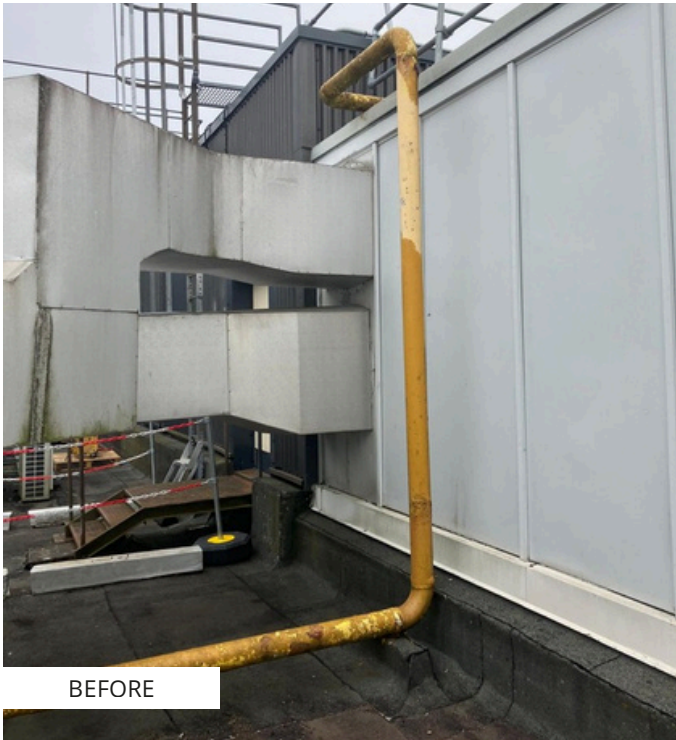
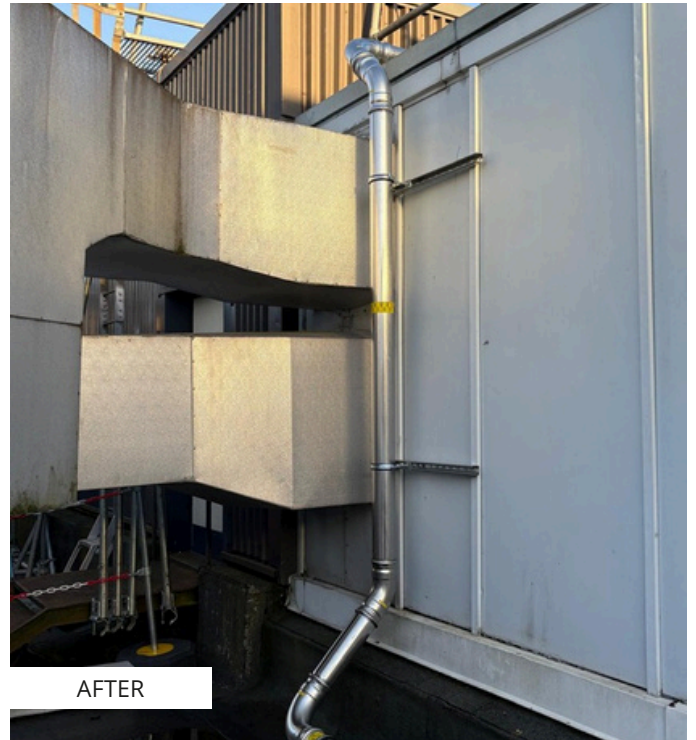
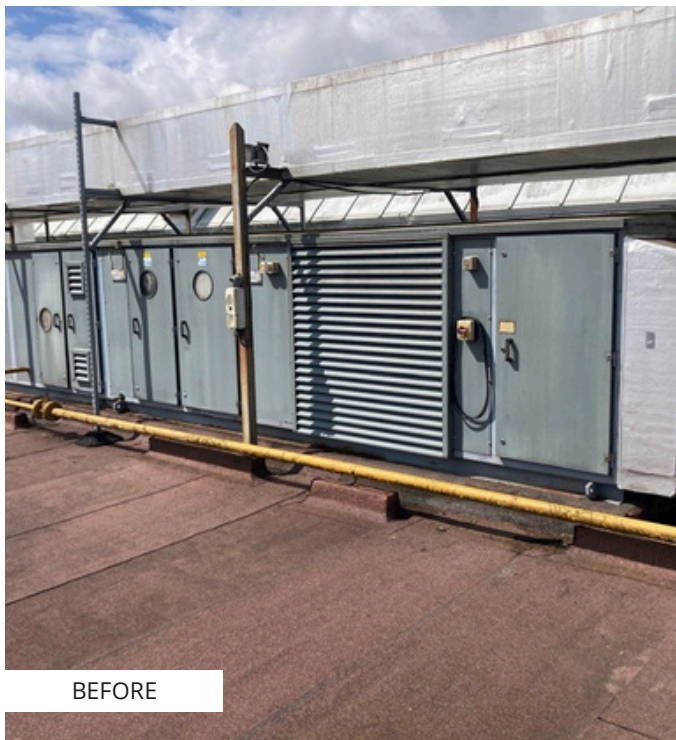
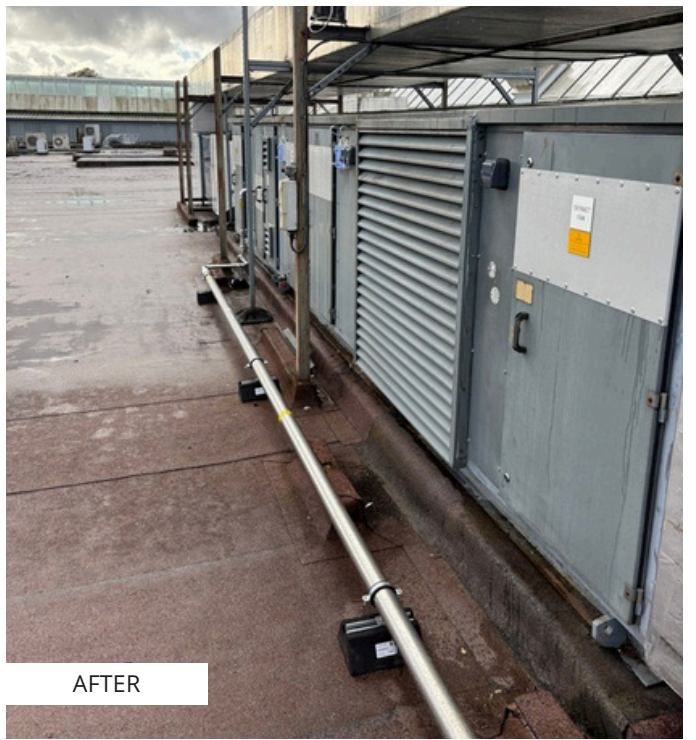
BEFORE

AFTER

The existing mild-steel gas distribution network was replaced with new 316-grade stainless-steel pipework, incorporating pressed joints, isolation valves, and durable Big Foot support systems for enhanced safety and reliability.

Gas Distribution Pipework Replacement

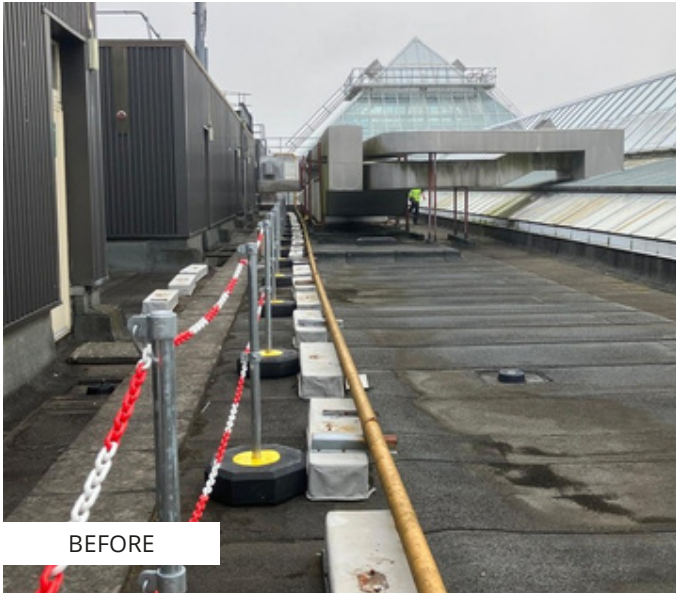
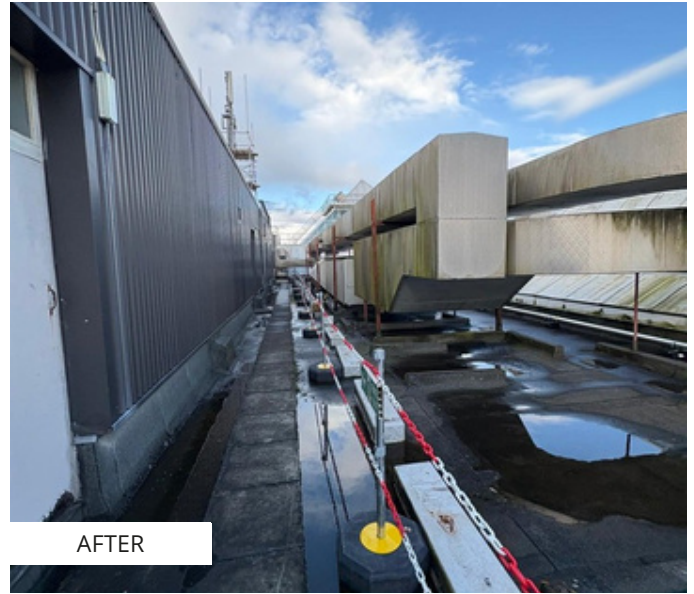
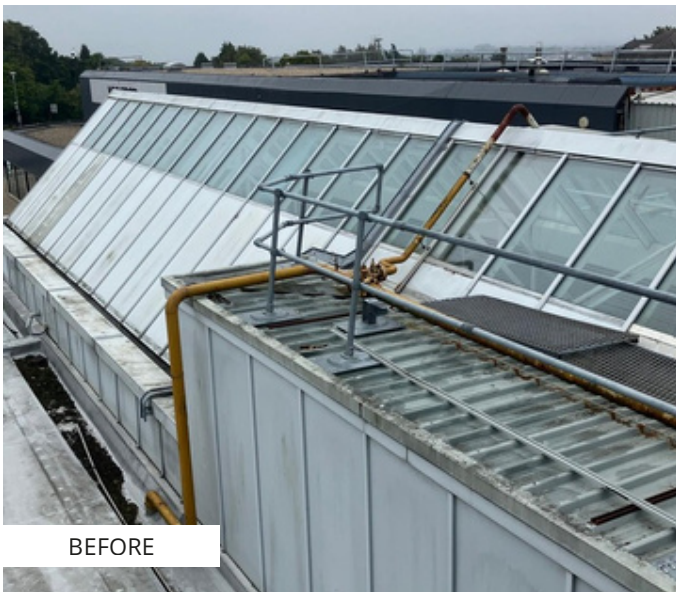
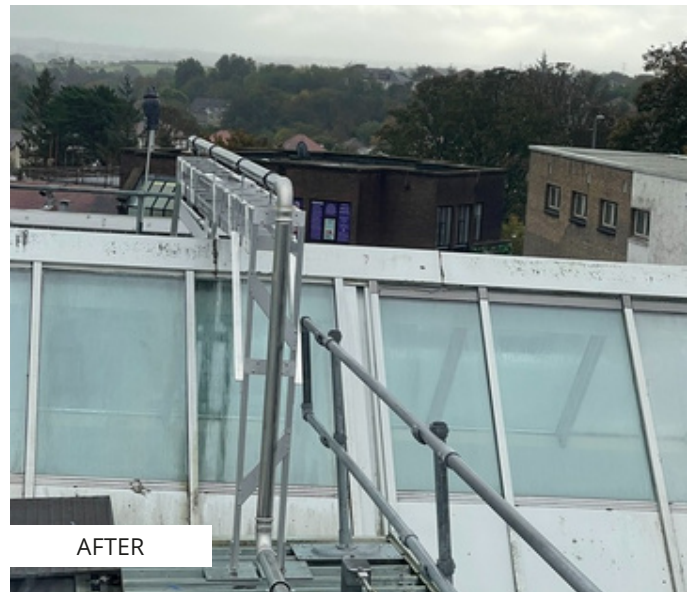
While some pipework routes were retained, many were adapted and reconfigured to improve efficiency and optimise system performance.

Gas Pipework Reconfiguration

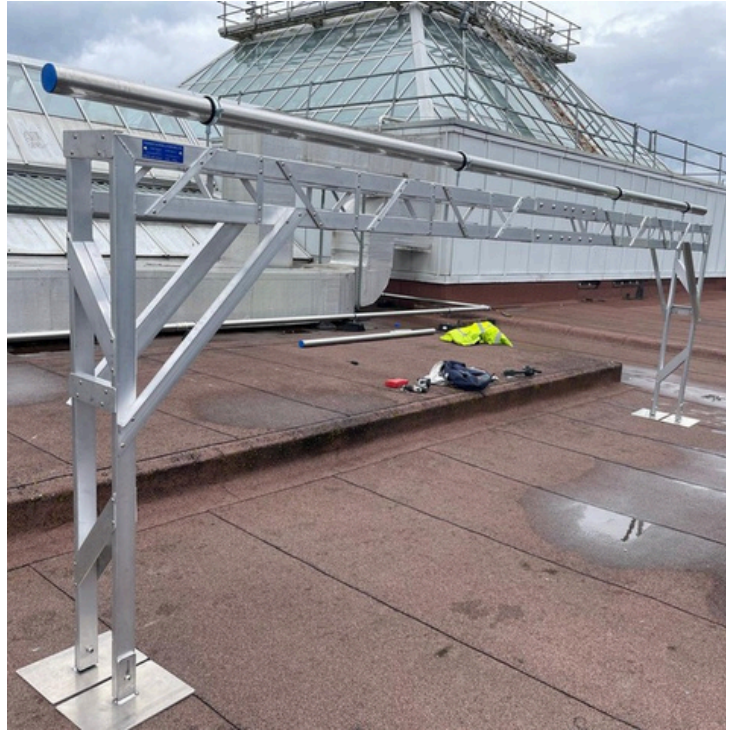
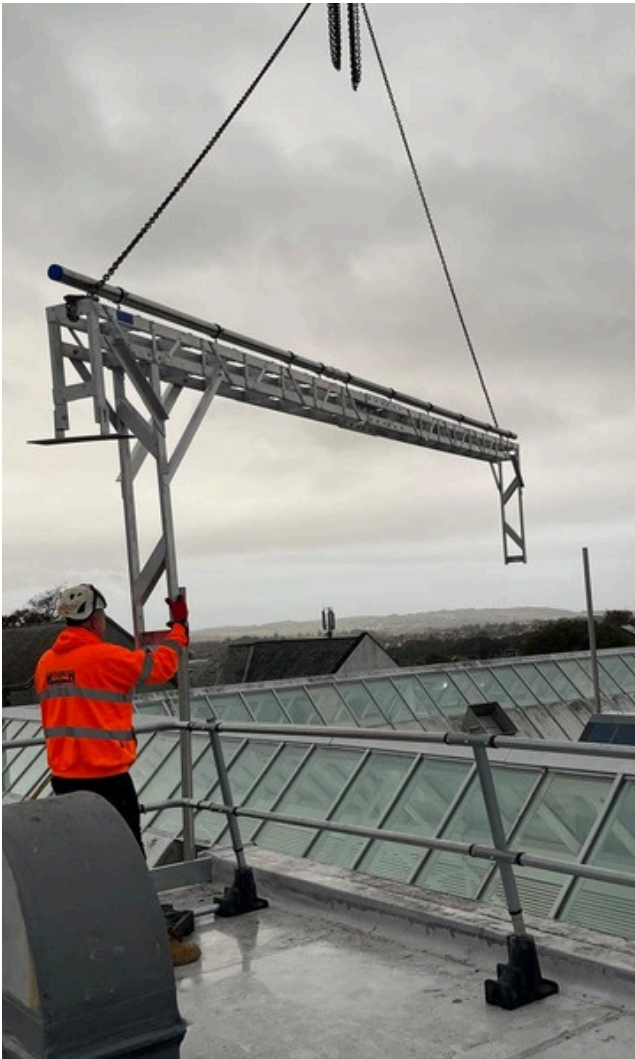
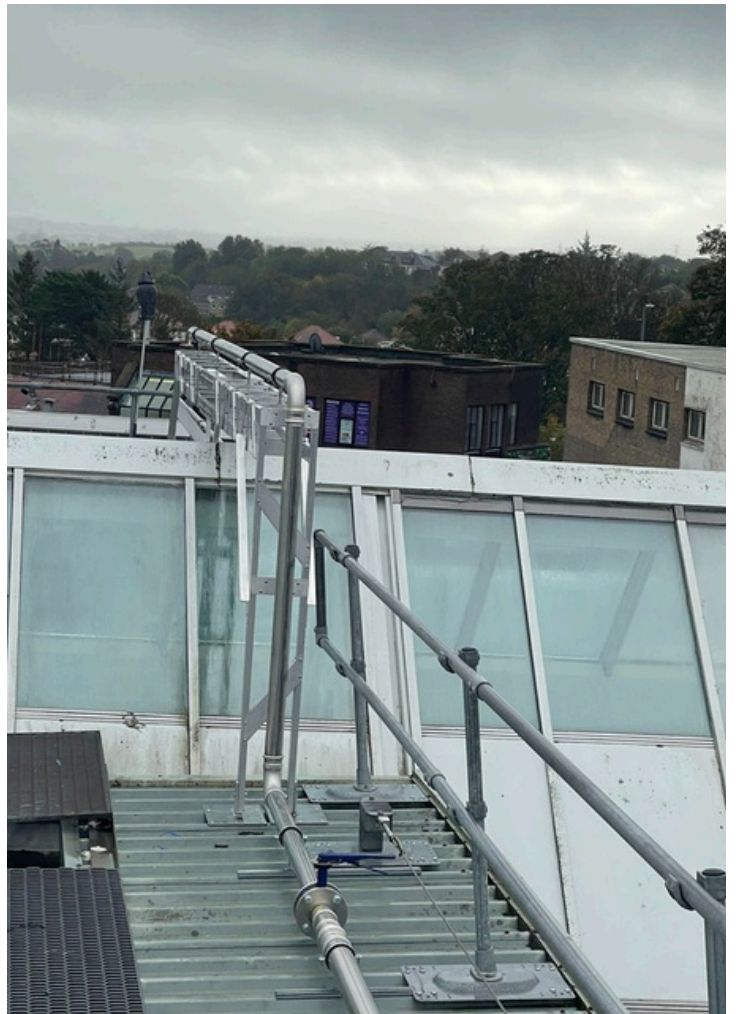
Our team manufactured a bridge scaffold to safely route the gas pipework over the shopping centre's glass structure without causing any damage. Once constructed, the bridge was carefully craned across the roof and positioned over the glass, allowing our engineers to securely bolt it in place and connect the gas. The operation was carried out outside of normal working hours to ensure safety and was meticulously coordinated with the crane team.

Gas Pipework Installation
