AHU Refurbishment Case Study

Middle Wallop - AHU Refurbishment

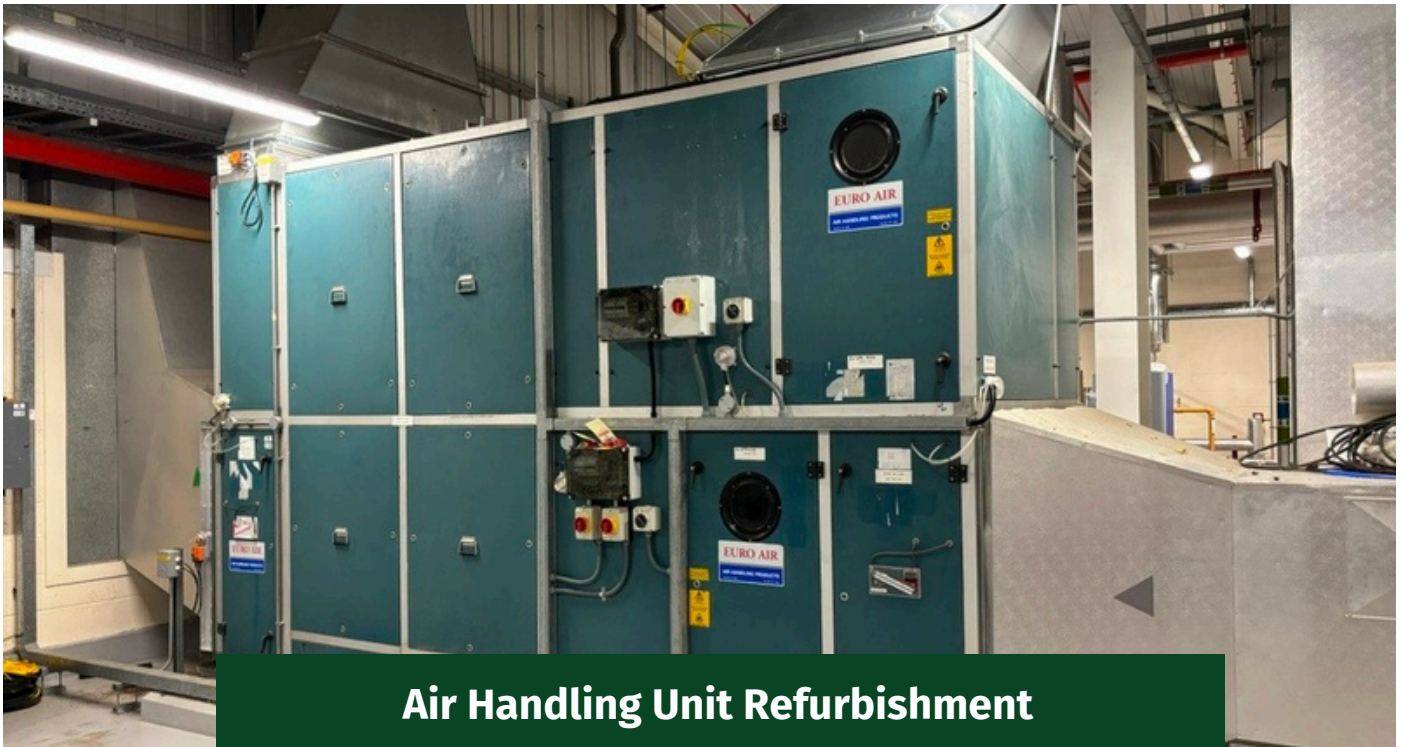
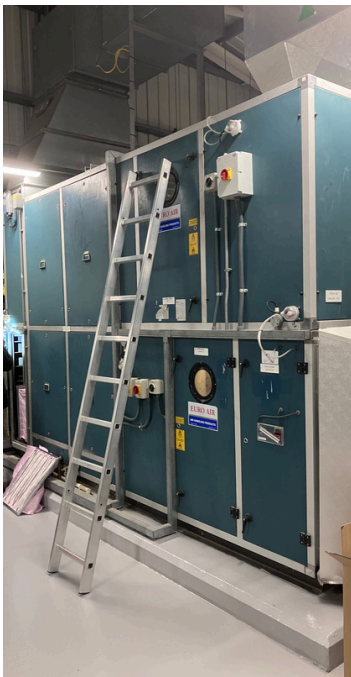
Following a detailed technical survey, we found the AHU casework to be in good condition and identified that a full replacement was unnecessary. Instead, we proposed a more cost-effective and sustainable solution: a complete AHU refurbishment. This approach not only saved the client around half the cost of replacement but also ensured the unit would continue to operate reliably for another 20 years or more – meeting all required standards without the disruption of a full system overhaul.

A technical survey assessed the AHU's condition, identifying corrosion, blockages, and mechanical issues to define the refurbishment scope.

Sections of insulation were removed and an access hatch installed to clear debris from the blocked louvre. Corrosion and water ingress were found, with further investigation advised.

The AHU was cleaned internally, corrosion treated, dampers, seals, and hardware replaced as needed, and filters and maintenance labels installed.

Existing fans were replaced with two efficient Ziehl-Abegg EC fans per unit, with new wiring and tamper-proof speed controls installed.

Airflow and fan speeds were tested and adjusted; final balancing awaited confirmation that all fire dampers were reset by the client.

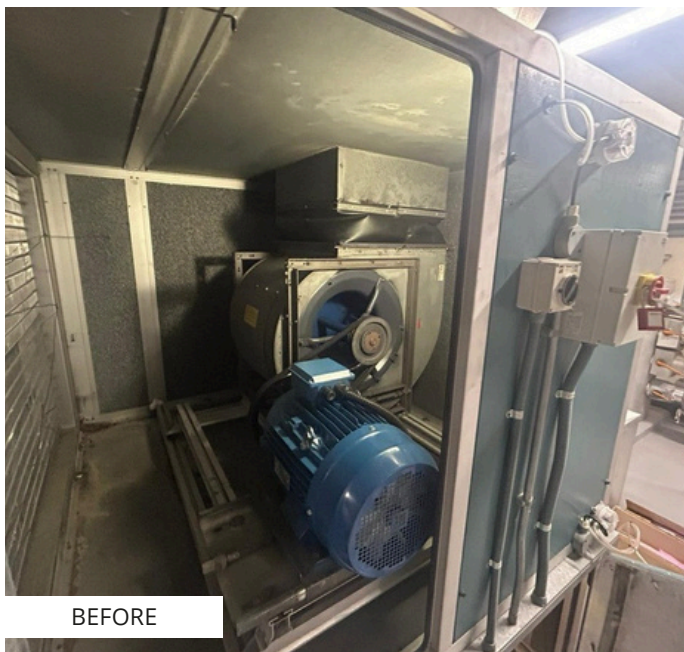
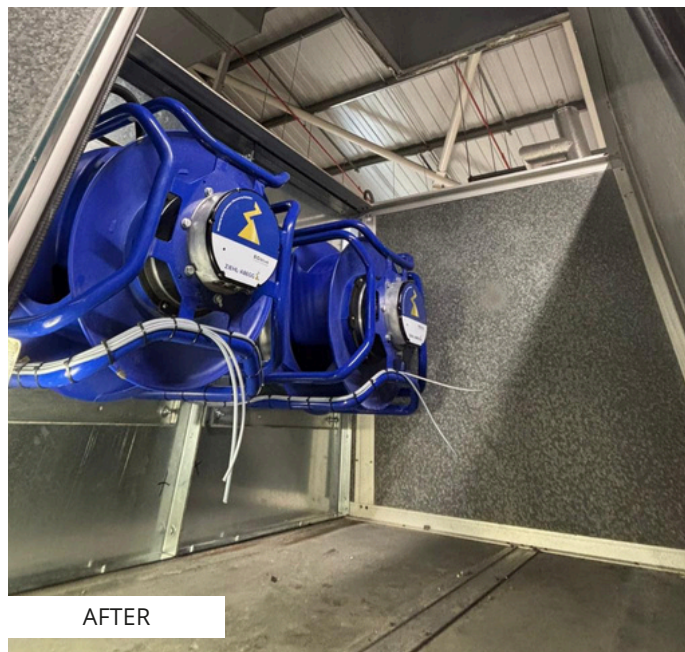
AHU Supply Fan Section Upgrades

BEFORE

AFTER

We removed the existing belt-driven supply fan, fabricated and installed new fan bulkheads, fitted two GR561-ZID EC fans for supply, then completed the wiring and carried out full testing.

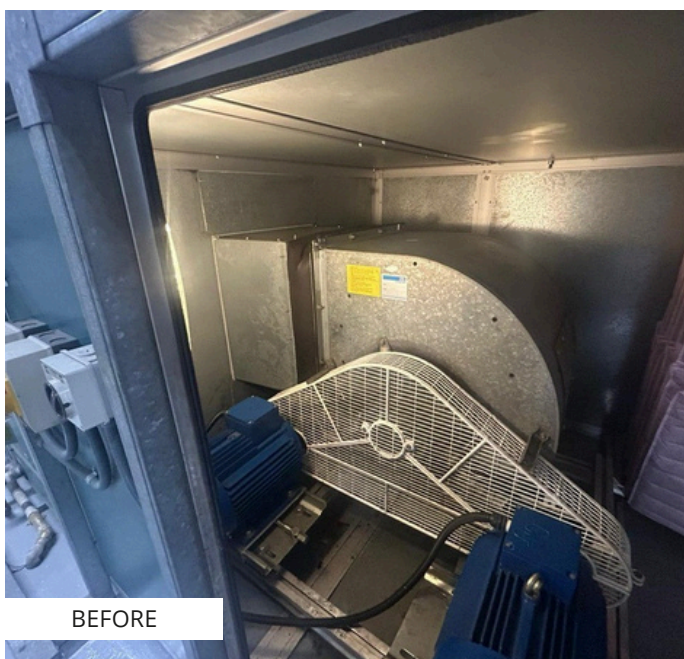
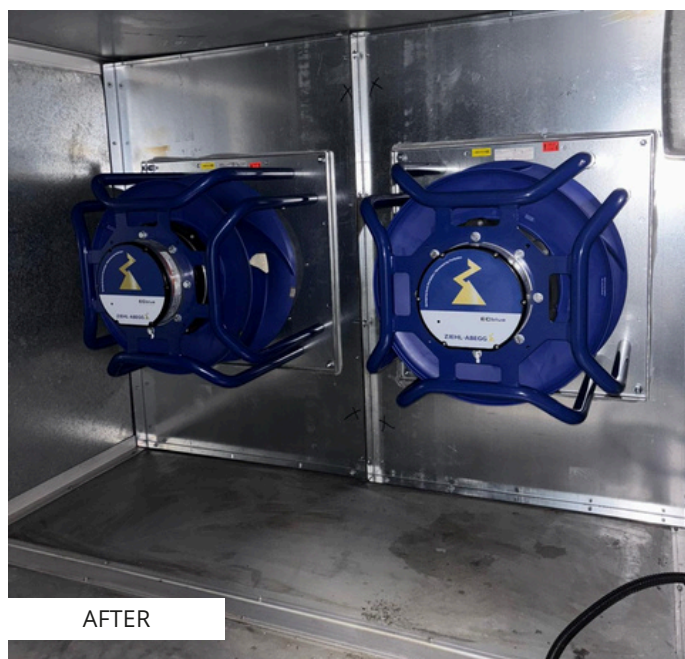
AHU Extract Fan Section Upgrades

BEFORE

AFTER

We removed the existing belt-driven supply fan, fabricated and installed new fan bulkheads, fitted two GR501-ZID EC fans for supply, then completed the wiring and performed comprehensive testing.

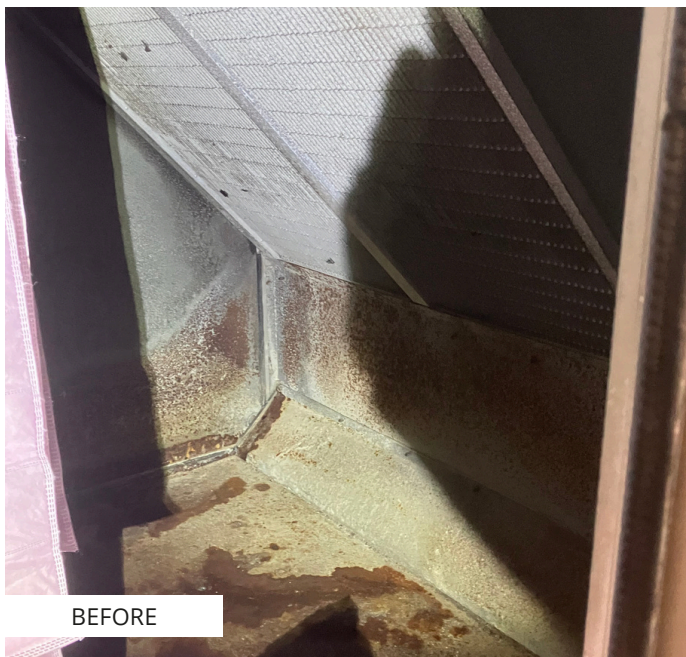
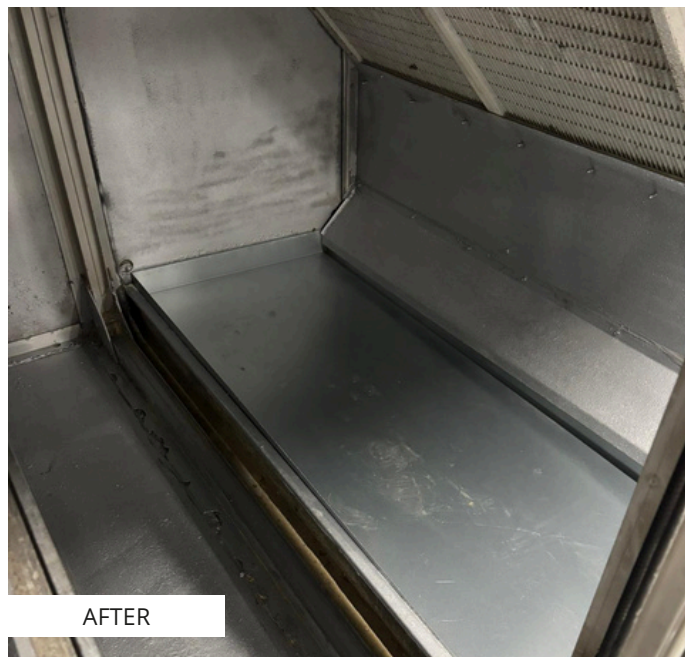
Replacement Condensate Drip Tray

BEFORE

AFTER

The existing condensate drip tray was removed due to signs of corrosion and water damage. A new, robust replacement was installed to ensure proper drainage and prevent future water ingress issues.
