# Case Study AHU Refurbishment Private Hospital

# Case Study - Private Hospital, Operating Theatre

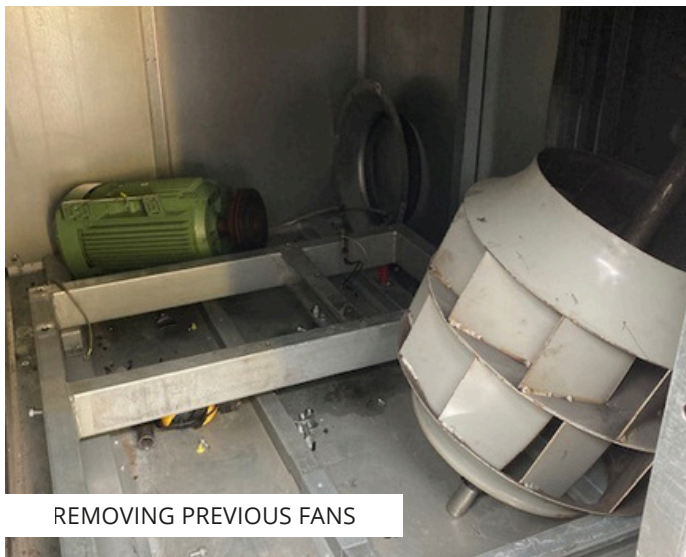
REMOVING PREVIOUS FANS

All outdated internal components were carefully stripped out to prepare the unit for refurbishment.

## Removal of Existing AHU Components

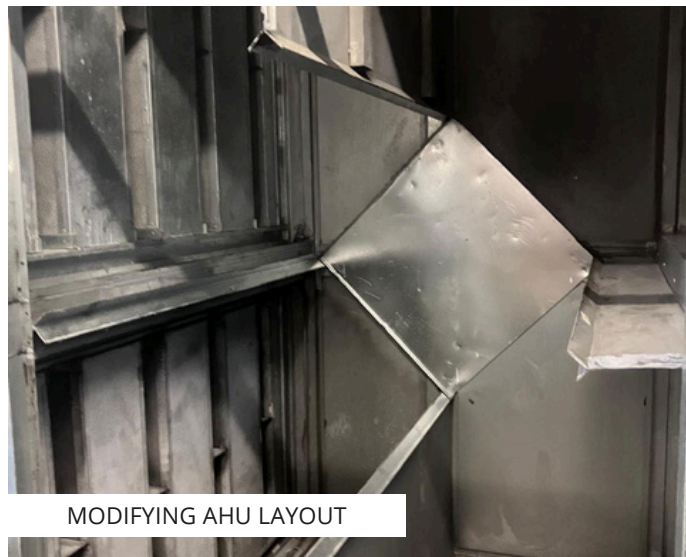
MODIFYING AHU LAYOUT

The existing AHU layout was reconfigured, including the fabrication of new fan bulkheads and structural metalwork, to accommodate modernised components.

## AHU Modifications for New System

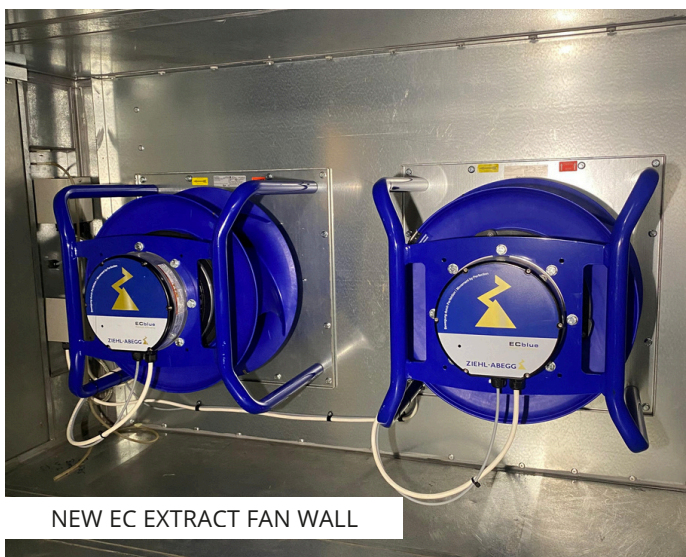
NEW EC EXTRACT FAN WALL

High-efficiency EC fans were installed on both the supply and extract sides, significantly improving airflow control and energy performance.

## Install New Supply & Extract EC Fans

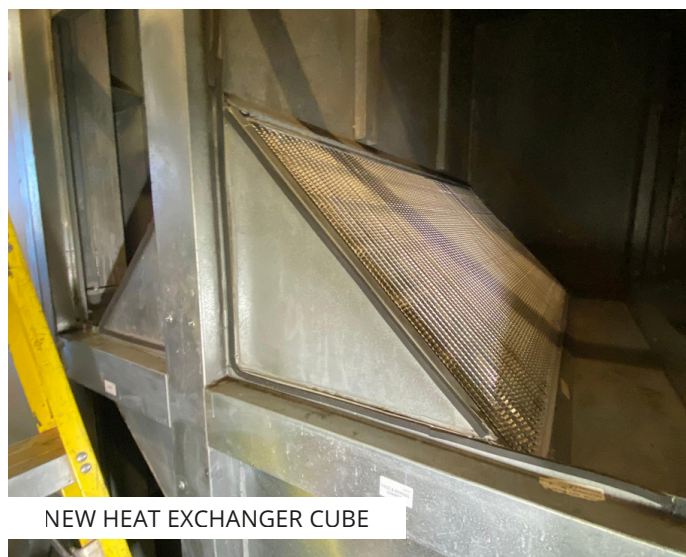
NEW HEAT EXCHANGER CUBE

A new cubic heat exchanger was designed, manufactured, and installed to enhance heat recovery efficiency within the system.

## Supply & Installation of Heat Exchanger
