BUILDING VENTILATION SOLUTIONS

Case Study Extract Fan & Duct Installation Kingly Street Office

Case Study - Kingly Street Office

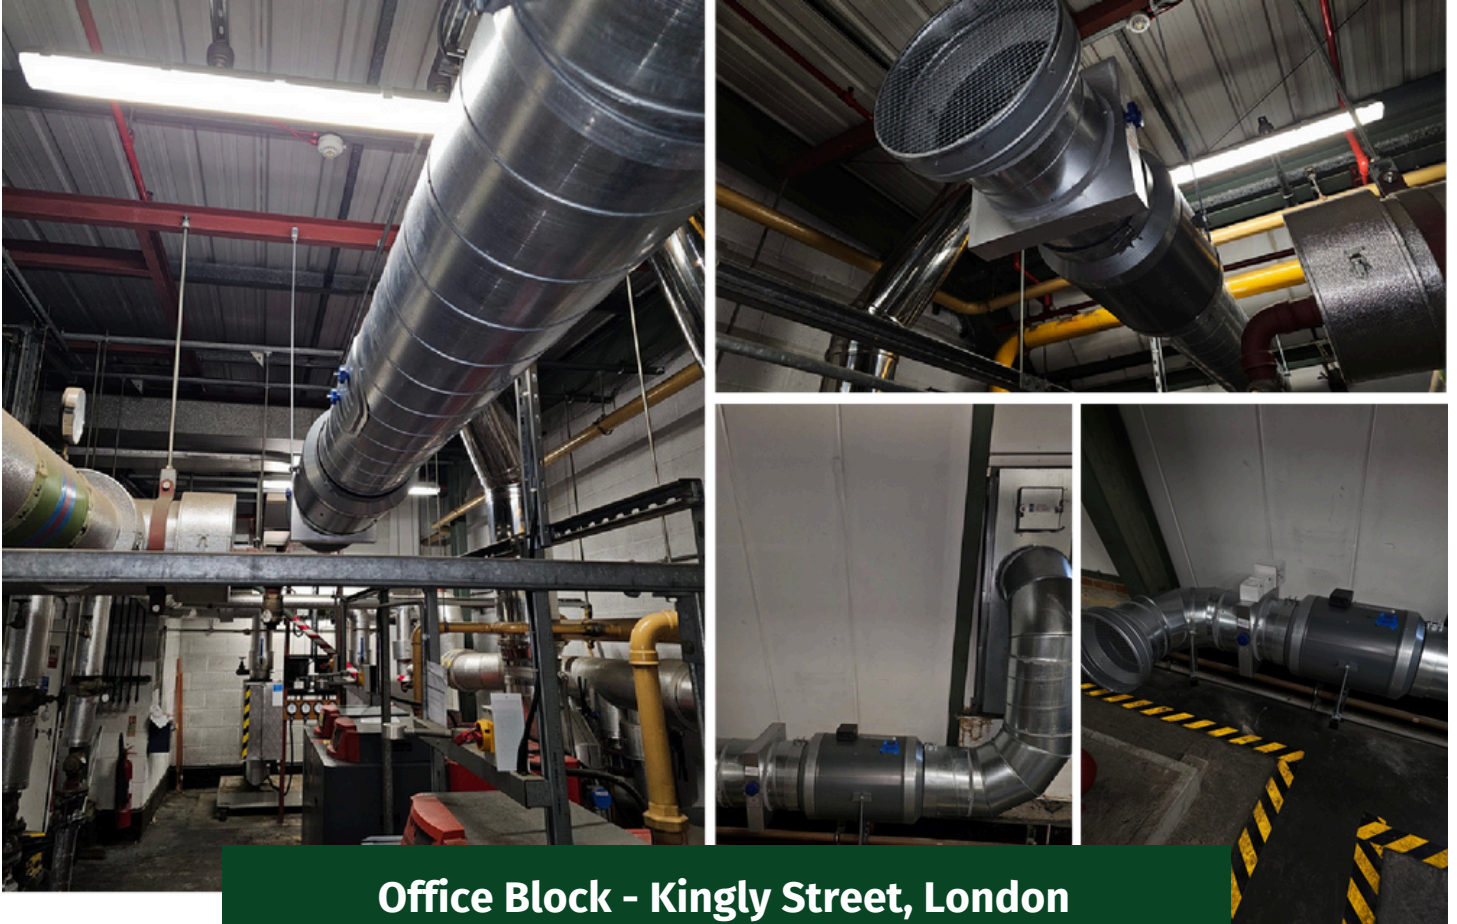
A fan rated at 0.752 m³/s was installed at a low level on the right-hand side of the plant room. Positioned under the existing fresh air louvers, the fan was connected to the window louver via new ductwork, which terminates with a bell mouth, ensuring consistent fresh air supply into the room.

The extract fan, rated at 0.361 m³/s, was installed at high level on the left-hand side of the plant room. The new ductwork connects this fan to the fresh air door louvers, effectively extracting air from the room and ensuring proper ventilation.

Both fans were wired into the existing mechanical distribution board (DB) to utilize the current electrical infrastructure. To enhance safety, automatic controls were added to the system, ensuring that the boiler(s) will automatically shut down if either fan fails to operate. These controls were integrated into the building's management system (BMS) to provide seamless monitoring and efficient operation.

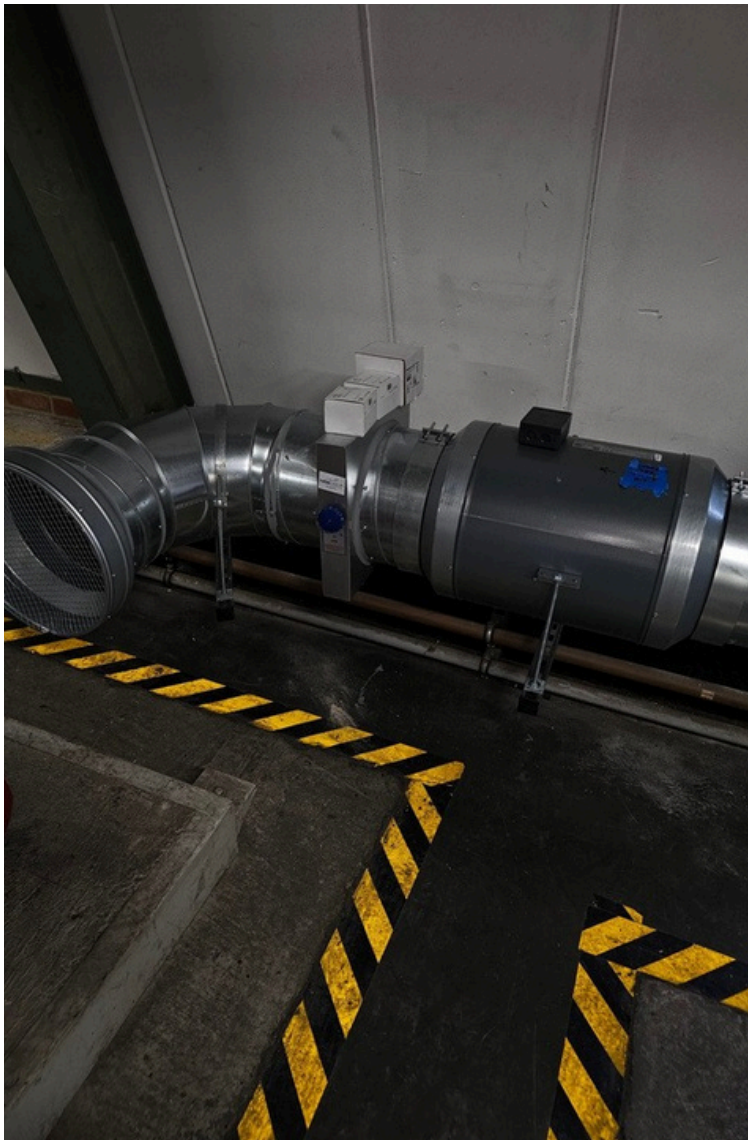
The new ventilation system was successfully installed, providing enhanced air circulation, improved safety measures, and seamless integration with the facility's existing control systems. This installation helps maintain optimal conditions in the boiler room, contributing to the overall efficiency and safety of the heating system.

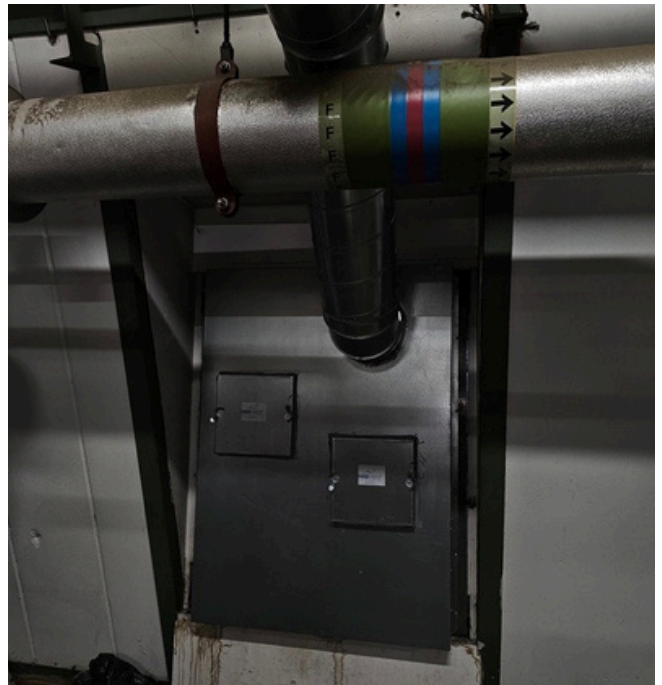
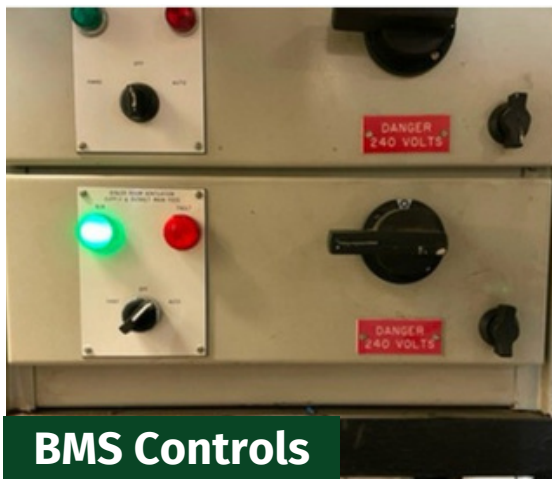
BMS Controls

Boiler Inlet Supply Fan: A fan rated at $0.752 \text{ m}^3/\text{s}$ was installed at a low level on the right-hand side of the plant room. Positioned under the existing fresh air louvers, the fan was connected to the window louver via new ductwork, which terminates with a bell mouth, ensuring consistent fresh air supply into the room. **Extract Fan:** The extract fan, rated at $0.361 \text{ m}^3/\text{s}$, was installed at high level on the left-hand side of the plant room. The new ductwork connects this fan to the fresh air door louvers, effectively extracting air from the room and ensuring proper ventilation.
