Case Study

AHU Refurbishment

Pembroke Offices

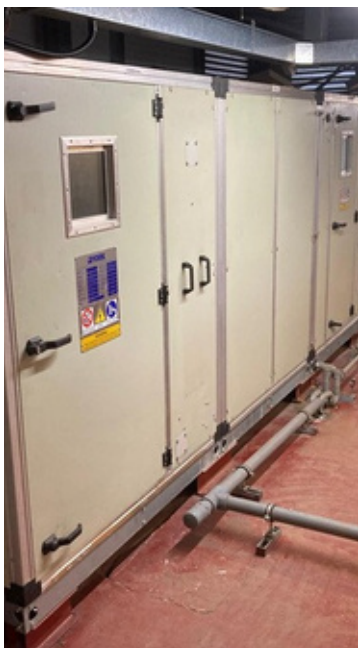
INLET DAMPER

Installed for better monitoring of filter status, helping maintain air cleanliness and reducing maintenance costs.

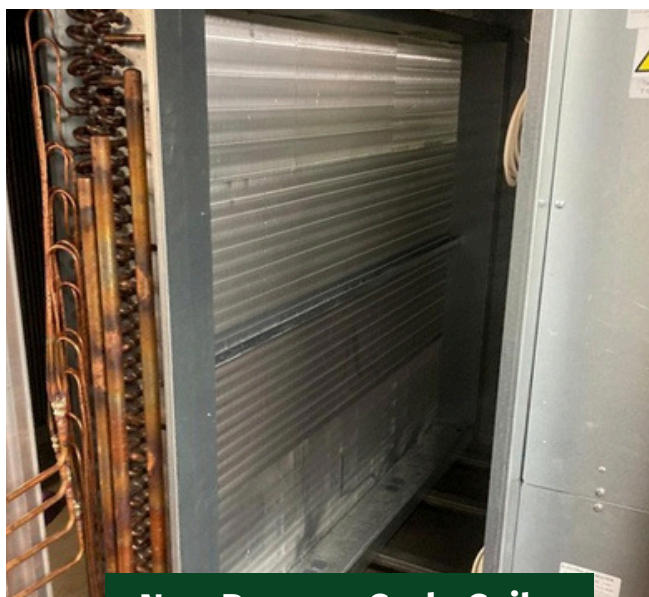
New Reverse Cycle Coil

REVERSE CYCLE COIL REPLACEMENT

All AHU-mounted coils, including the frost coil, heating coil, run around coil, and cooling coil, were removed. A new reverse cycle coil was installed in place of the removed coils.

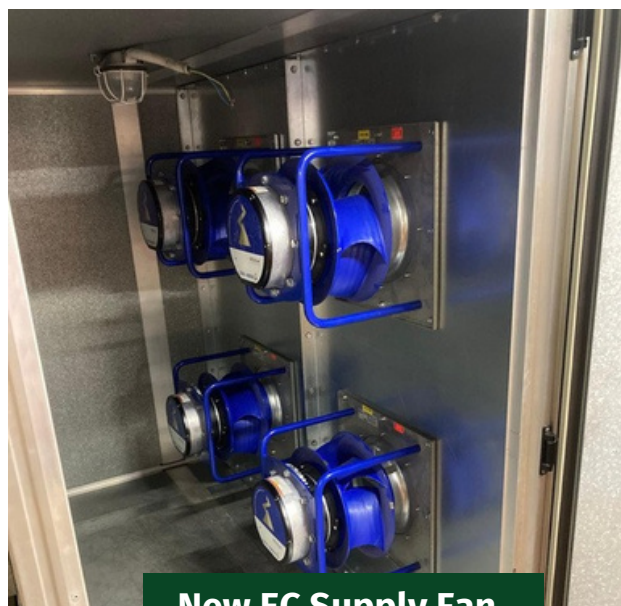
New EC Supply Fan

SUPPLY FAN & MOTOR REPLACEMENT

The existing belt-driven supply fan and motor were removed. A new fan bulkhead was supplied and fitted with three Ziehl EC fans. Fan power cables were wired to an isolator switch, and the controls were wired to a potentiometer.

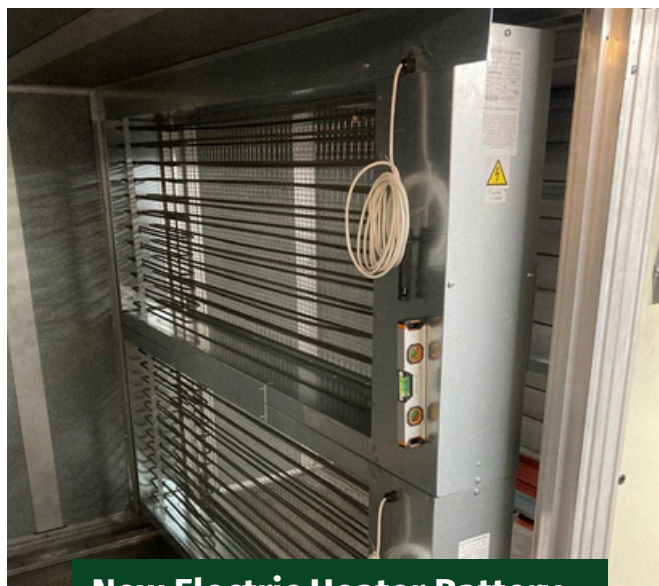
New Electric Heater Battery

ELECTRIC HEATER BATTERY REPLACEMENT

A new free-issued Electric Heater Battery (EHB) was installed, consisting of two 42kW EHBs to provide a total of 84kW heating capacity. All necessary metalwork to fabricate the EHB duct heater section was supplied and installed. Wiring was handled by other contractors.
