**WARNER LEISURE HOTEL
GUNTON HALL**
AIR HANDLING UNIT MANUFACTURING

PROJECT OVERVIEW

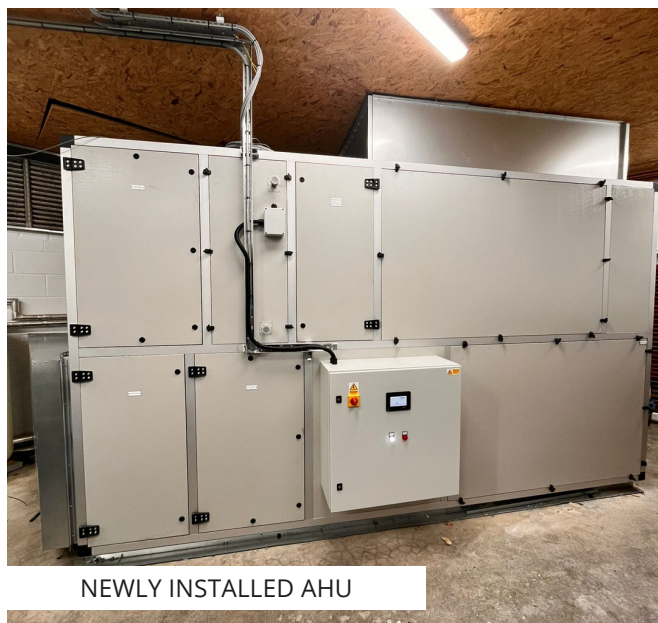
NEWLY INSTALLED AHU

The new AHU incorporated a high-efficiency plate heat exchanger to recover the maximum energy possible from the exhausted & remove moisture at all times of the year.

To save additional energy during low occupancy periods, the unit includes both temperature & humidity sensors & also a recirculation damper so that air can be returned directly when the humidity is low, thus enhancing energy saving potential

Because of the limited space requirements available in the existing plantroom, the new AHU had to be tailor-made so as to fit, particularly as it was larger than the original.

The unit also had to be manufactured to be highly resistant against corrosion & so was manufactured from plastic coated galvanised steel panels. All double-skinned & insulated within a 50mm aluminium frame

Because of the reduced access into the plantroom, the unit had to be provided in flatpack form. The new unit panels were moved into the plantroom where our engineers then re-built it. The connections onto the existing ductwork had to be modified & our engineers undertook this, as well as fitting new lagging. In addition the LPHW heating pipework had to be re-routed & re-connected with a new 3-port control valve by our engineers

The unit was fitted & pre-wired with an on-board Trend control panel & following installation, our engineers then commissioned both the unit & controls, measured the air volumes & set to the increased volume & left the unit running to the clients satisfaction

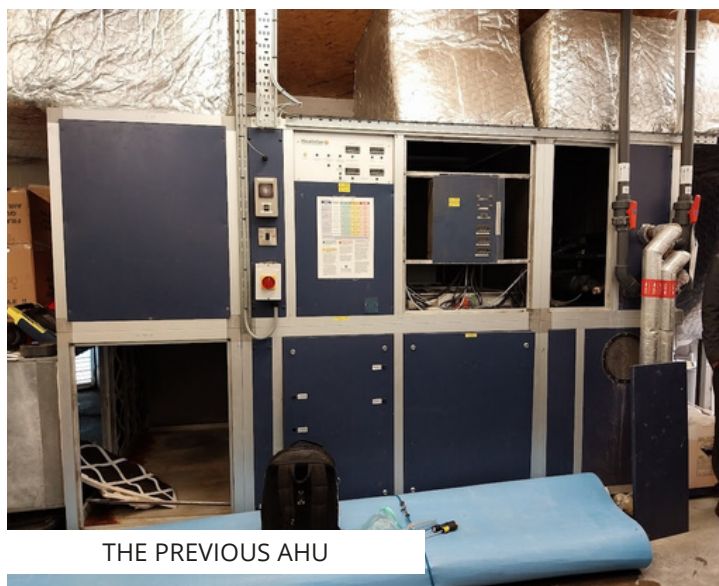
THE PREVIOUS AHU

The existing AHU at Gunton Hall had come to the end of its useful life & needed replacing & so we were approached to investigate the existing set-up & then design, manufacture & install a new air handling unit complete with fitted controls

In reviewing the existing AHU against our design criteria, it was felt that the air volumes need to be increased, particularly to cope with the fully glazed structure of the pool hall itself & reduce condensation on the glazing. So the new AHU was designed to provide additional air to meet this need
